# GUNITE Service Bulletin

## Spoke Wheel Stud Installation

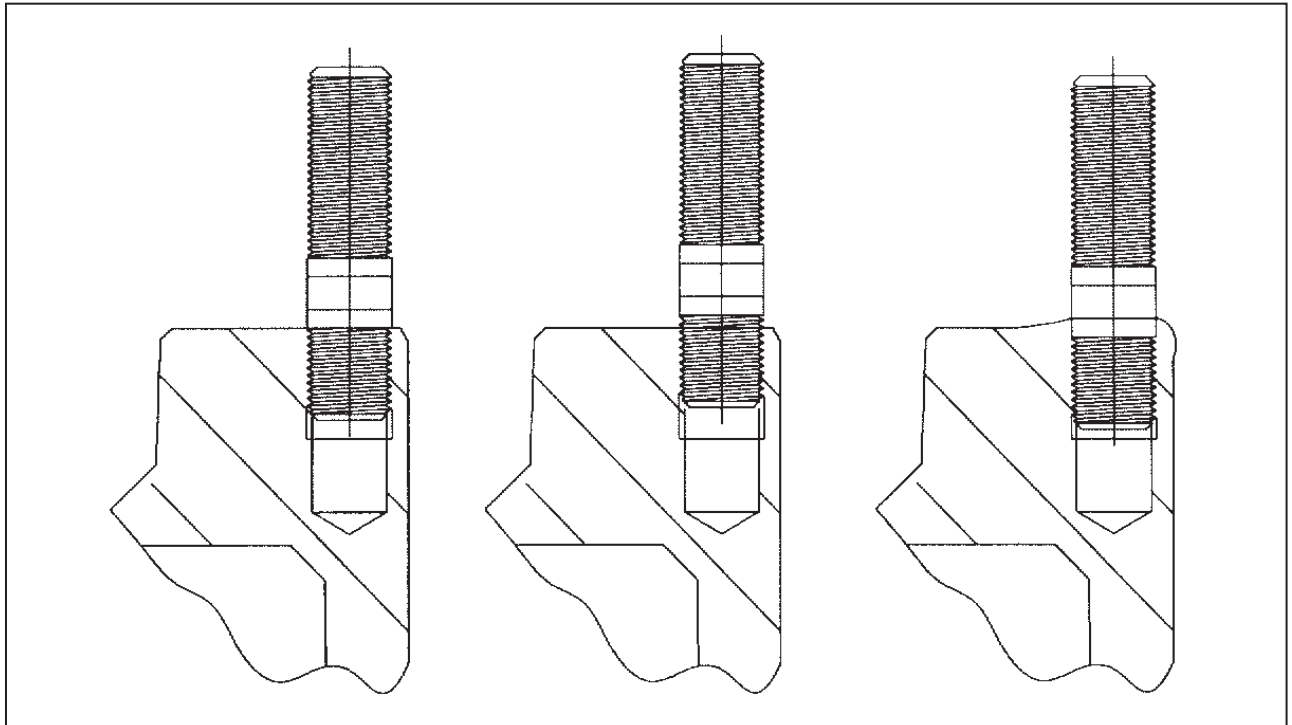
Acceptable	Not Acceptable	Not Acceptable
Stud shoulder should be seated uniformly against or flush with the surface of the spoke face. The exception being less than 100% uniform seating due to minor surface irregularities in the casting.	Stud is not completely seated. Threads are visible between shoulder and top of spoke. (Undertorqued)	Stud is driven past shoulder to point of deforming spoke face. (Overtorqued)

Warning: Overtorqued clamp studs will cause damage to the studs and/or spoke face and could result in rim loss. Undertorqued clamp studs will cause damage to the studs and could result in rim slippage or rim loss.

When replacing rim clamp studs on Spoke Wheels the studs must be torqued to a minimum of 40 ft. lbs. The above illustrations show the correct shoulder contact to the spoke face after installation.
